# Case Study of Slope Investigation on the Cretaceous Sedimentary Rocks Using the Geological Cross-Sections

## Abstract

**Keywords:** slope investigation, sedimentary rock, toppling failure, face-mapping, geological cross-section, stereonet projection

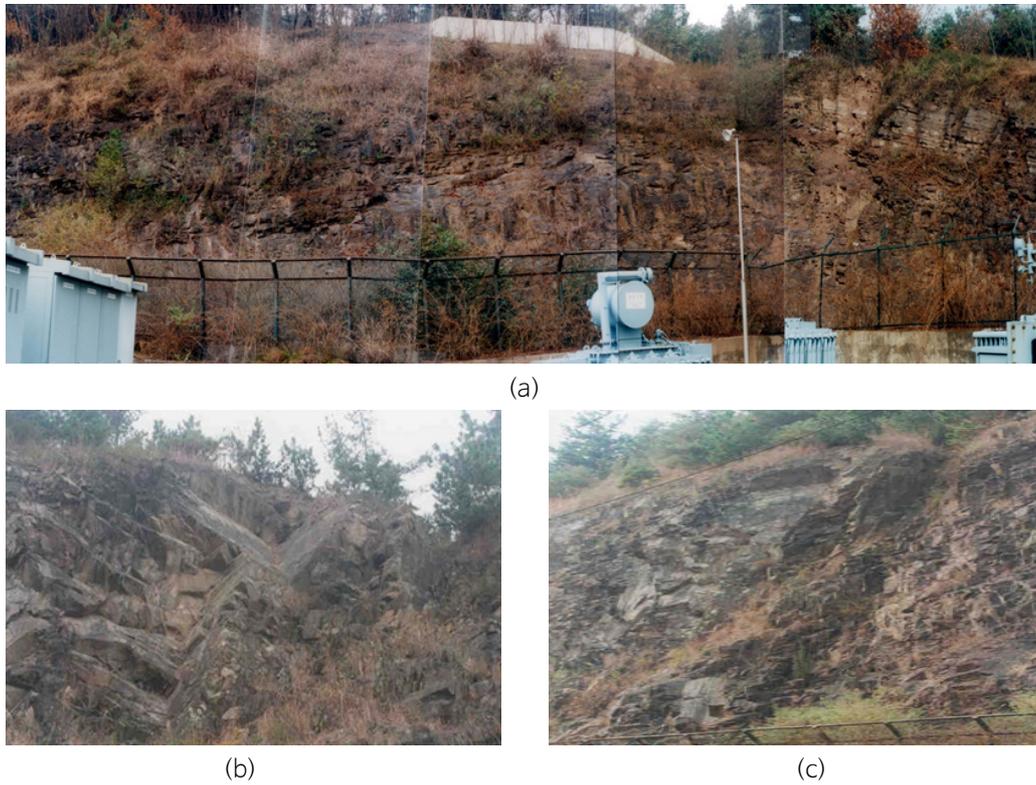
The bedding plane is well developed in the rock layer of the slope, which is the feature of sediment rock, and partially penetrated by two dacite dykes. Several wedge failures (Fig. 2b) occurred according to the shear joint surface in the rock body whose volume was around  $2\sim 3\text{ m}^3$  (Fig. 3) at STA. No. 6~8 and plane failures occurred along the contact surface of the dacite veins penetrated at STA. No. 6~7 in the slope (Fig. 2c). Furthermore, the rock body whose volume was around  $0.002\sim 0.003\text{ m}^3$  showed toppling failures and a small scale of rockfall in the upper and middle ends of the whole slope section (Fig. 3). The weathered condition of the rock was good but the clay mineral embedded in the stratified and intrusive contact surfaces of shale showed a very fast weathering rate.

Fig. 2. The outcrop photos. (a) The foreground photo for the slope of the study area, (b) The outcrop photo for wedge-failure on shear joints of the slope, (c) The outcrop photo for plane-failure on contact plane at dacite dyke of the slope.

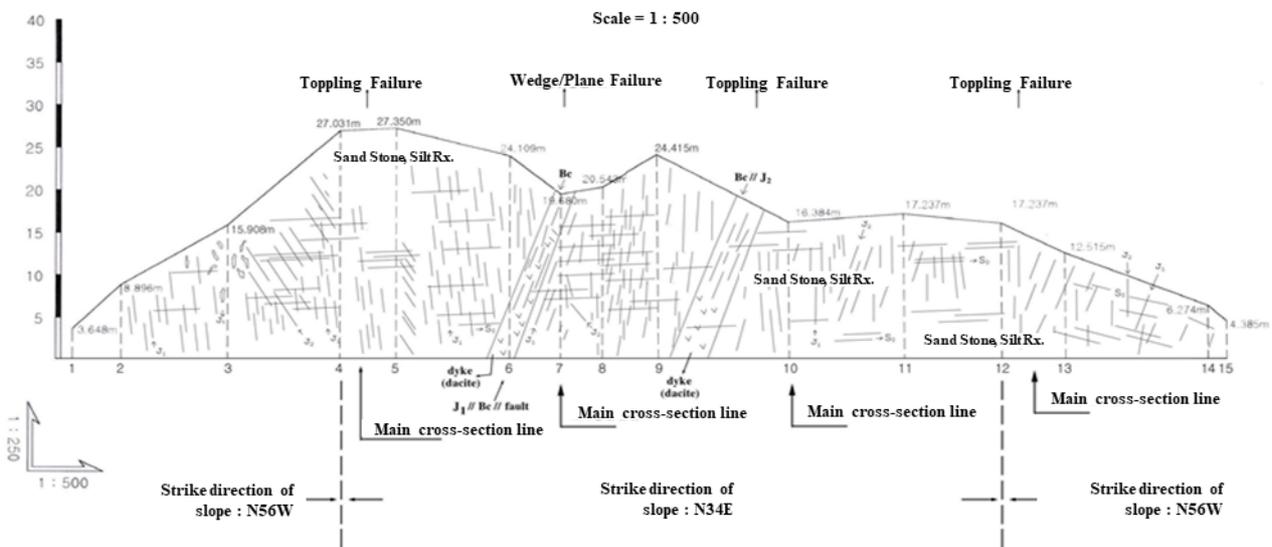
The type of discontinuity surface inside the rock can be divided into bedding, shear joint, and intrusive contact and tension joint. The tension joint developed in the upper end of the slope played the role as the main fracture planes in STA. No. 1~4, the shear joint in STA. No. 4~6, the intrusive contact and shear joint in STA. No. 6~10, and bedding and

shear joint in STA. No. 11~14. The rock properties in each section inside the slope are presented in Table 1. Fig. 2a shows the photo of the slope and Fig. 3 shows the geologic front-view map that displays the rock composition in the slope, discontinuity type, orientation, spacing, and persistence.

Fig. 3. The unfolded drawing map for geological face-mapping data of the slope.

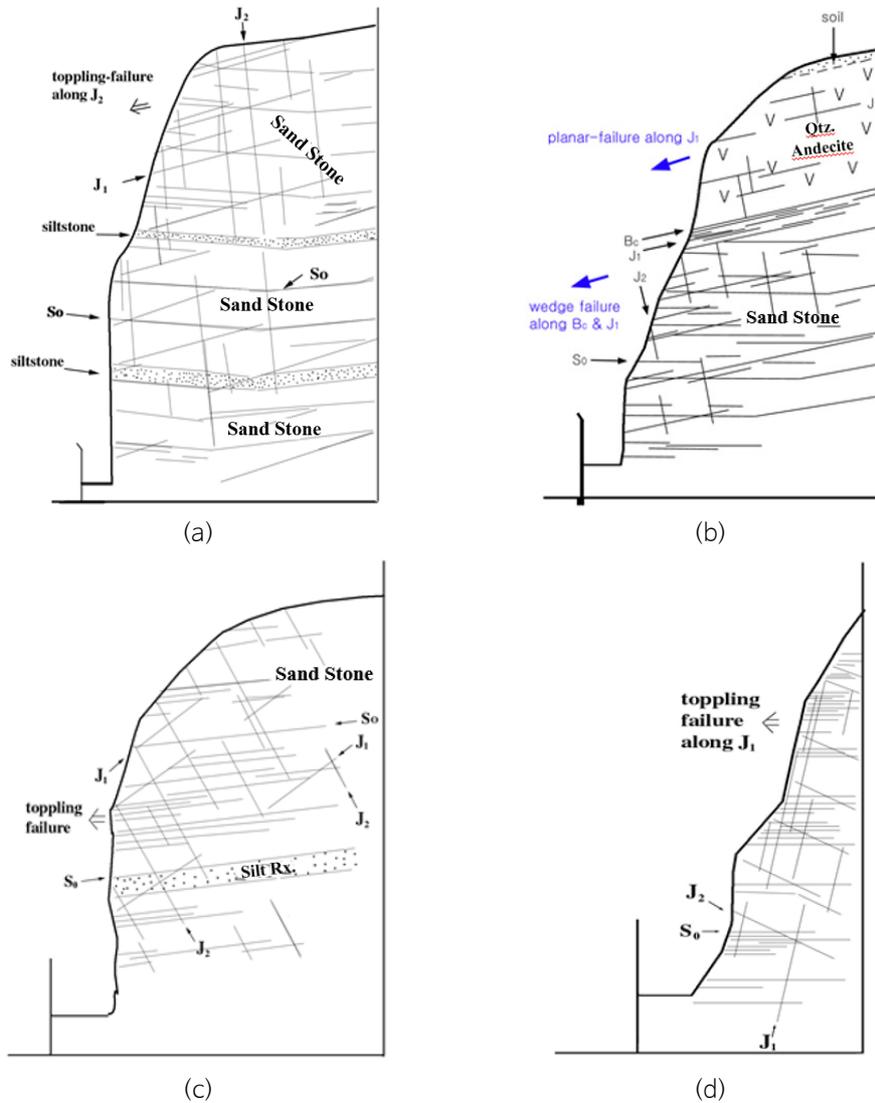
The analysis result of the geologic cross-section in Sta. No. 4 showed that the toppling failure occurred along the high-angle joint (Fig. 5a) and the toppling failure also partially occurred in the slope. As shown in Fig. 5b, the analysis result of the geological cross-sectional view in Sta. No. 7 showed that a plane failure occurred along the low-angle joint as well as a wedge failure occurred in the rock block where the intrusive contact of dacite dykes and low-angle joint were met.

Fig. 5. Geological cross-section of (a) Sta. No. 4, (b) Sta. No. 7, (c) Sta. No. 10 and (d) Sta. No. 12 on the cut-slope.

The analysis result of the geologic cross-section in Sta. No. 10 showed that the toppling failure occurred along the high-angle joint, which was the opposite slope direction, (Fig. 5c) and the toppling failure also frequently occurred in the slope. In addition, as shown in Fig. 5d, the analysis result of the geological cross-sectional view in Sta. No. 12 exhibited that a toppling failure was likely to occur along the high-angle joint.

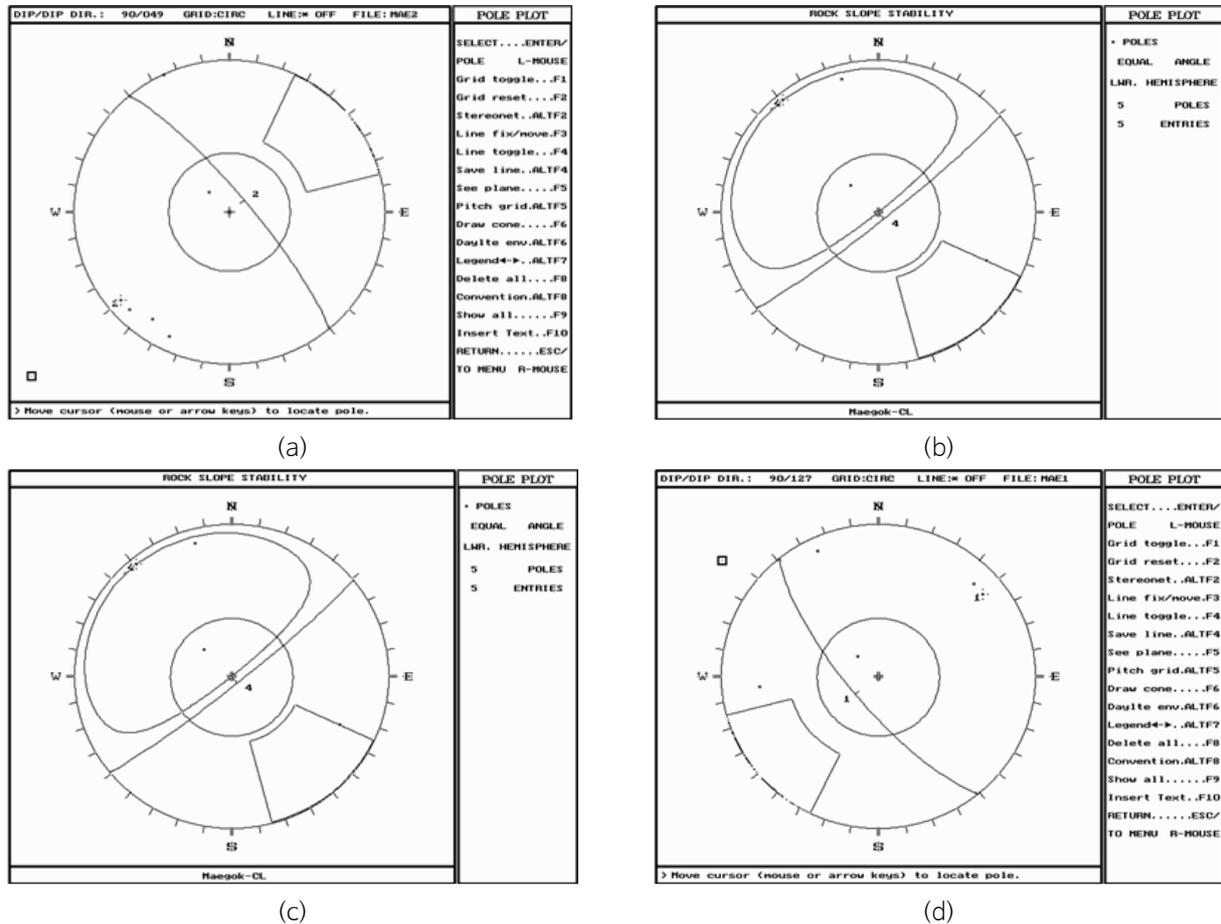
To review the slope stability, overall characteristics and failure types of the main discontinuity in four representative cross-sections were analyzed (Table 6) and stereographic projections of given discontinuities were conducted to estimate a possible failure direction. The stereographic projection drawing (equal-area lower-hemisphere projection) of bedding, shear joint, tension joint, and intrusive contact were created and the results are shown in Fig. 7.

The failure size of the rock body was 0.2~0.3 m<sup>3</sup> on average but the failure size of STA. No. 6~8 cross-section (in case that the intrusive contact zone was distributed) was 2~3 m<sup>3</sup>, which was relatively larger. The load of the failure rock body was around 6 ton · m on average. The sliding direction of the failure rock body showed that in the case of STA. No. 4, STA. No. 10, and STA. No. 12 cross-sections, the toppling failure along the shear joint surface was expected to occur in the gravity direction, and in the case of STA. No. 7 cross-section, the wedge failure along with the intrusive contact and shear joint surface in the 60° southeast direction, and the toppling failure along with the shear joint surface in the gravity direction of the southeast direction.

**Fig. 7.** The stereonet projection map of discontinuities at (a) Sta. No. 1~4, (b) Sta. No. 4~9, (c) Sta. No. 9~12 and (d) Sta. No. 12~15 on the slope.

As presented in Table 6, Sections STA. No. 3~5 and STA. No. 10~11 showed an unstable state and Sections STA. No. 6~8 exhibited a highly unstable state and Sections STA. No. 12~13 revealed a somewhat unstable state. Thus, a countermeasure method is required overall to improve the stability of the slope.

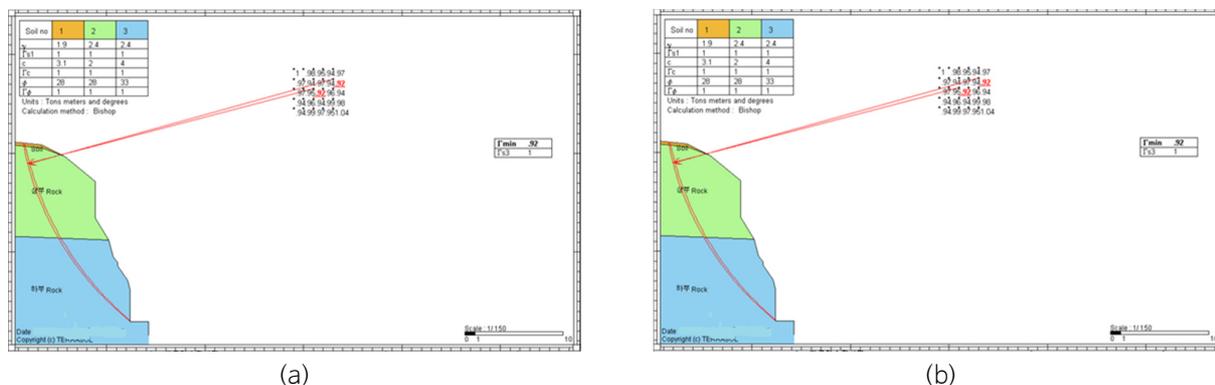
To conduct a stability analysis of the slope, the strength, which was derived in Section 3.4 for the STA. No. 4, STA. No. 7, STA. No. 10, and STA. No. 12 cross-sections, was used as an input value to calculate a safety factor of the representative slope during the dry and wet periods as mentioned earlier. TALREN 5.0 program was used in the limit equilibrium analysis. The period was divided into dry and wet periods and a safety factor analysis was conducted in the in-situ ground for each representative cross-section and only the results in STA. No. 7 are shown in Fig. 8 due to the limited space in this paper. Table 7 summarizes the safety factor at the dry and wet periods for each representative cross-section of the in-situ ground in the slope. The analysis results of the in-situ ground slope revealed that the safety factors in both dry and wet periods did not satisfy the allowable safety factors, which required a countermeasure method.

Fig. 8. The result of safety factor (Fs) at (a) STA. No. 7 on the slope in the dry season and (b) STA. No. 7 on the slope in the rainy season.

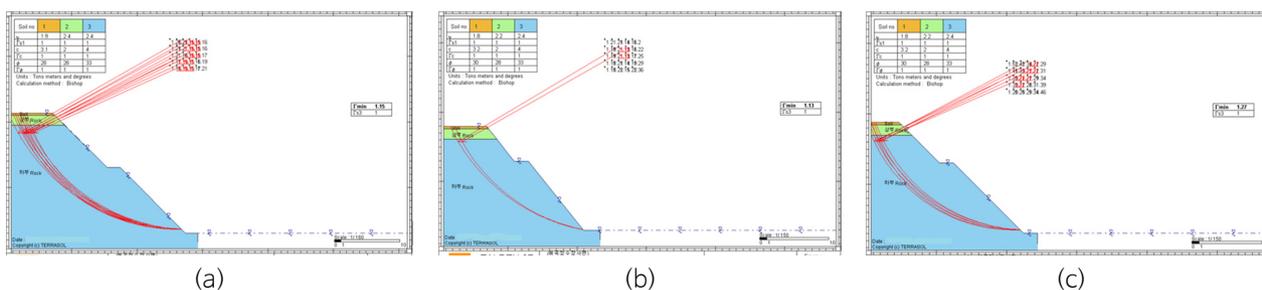
Fig. 9. The result of safety factor (Fs) at (a) STA. No. 7 after relief of the gradient on the slope in the rainy season, (b) STA. No. 10 after relief of the gradient on the slope in the rainy season and (c) STA. No. 12 after relief of the gradient on the slope in the rainy season.

The failure type for each representative cross-section found through the geological cross-sectional view analysis and analysis results of stereonet projection analysis exhibited that a small scale (1~2 m<sup>3</sup>) of rockfall in the upper side or a toppling failure along the shear joint surface was expected in the gravity direction and a wedge failure along the joint surface was also expected in the southeast direction for some. These results indicated that applying the slope gradient relief method, which was proven and economical considering the field circumstance overall, would be most reasonable. It was reasonable that the STA. No. 3~5 sections were needed to be cut to have the slope gradient gentler than 1:0.6, and the STA. No. 6~8 sections were needed to be cut to have the gradient gentler than 1:1 (Fig. 9a), and the STA. No. 10~13

sections were needed to be cut to have the gradient gentler than 1:0.6 (Fig. 9b & c). In addition, a 10 m-high and 1 m-wide step was needed to be installed according to the design code. Moreover, a rockfall prevention fence was needed to be installed on the slope and green soil surface treatment ( $t = 10$  cm) was needed to be installed. Table 8 presents the stability review results after a slope relief method was applied using the set strength integer.
