# Case Study of Slope Investigation on the Cretaceous Sedimentary Rocks Using the Geological Cross-Sections

## Abstract

**Keywords:** slope investigation, sedimentary rock, toppling failure, face-mapping, geological cross-section, stereonet projection

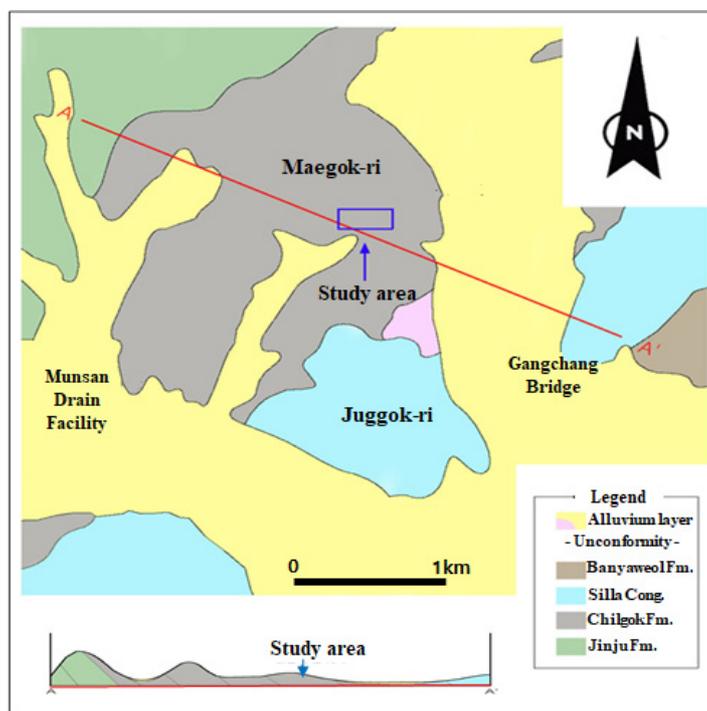
Fig. 4. Geological map and cross-section map (A-A') of the study area.

The rock in the study area was non-marine sediment rock that belonged to the Gyeongsang Supergroup, the Hayang Formation, and the Chilgok Formation deposited in the Cretaceous period of the Mesozoic age (GSK, 1928a, 1928b), and was red in color, which indicated it was formed under an oxidizing environment (Fig. 4). Two intermediate dacites, which were penetrated along the discontinuity surface at a later stage by making the sediment rock as parent rock, were penetrated and distributed several meters wide (Fig. 3).

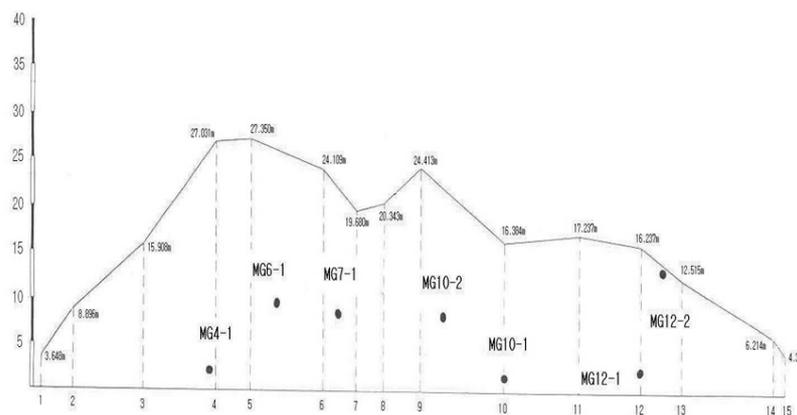
Fig. 6. The location map of rock samples on the slope (MG: sample No.).

The physical properties and mechanical tests of eight rocks collected in the representative locations (Fig. 6) inside the slope that reflected the rock type and discontinuity characteristics were conducted. The test items were specific gravity, water content ratio, absorption rate, wet unit volume weight in the physical test, and uniaxial compression and point load strength tests. The results are summarized in Table 3.
